# Investigation of Soil Erosion in Pothohar Plateau of Pakistan

**Abstract** | The research aims to investigate soil erosion in Pakistan in order to provide a scientific basis for the prevention and control of soil erosion in Pakistan and for the understanding of the ecological environment status in Pan-Third Pole. The Pothohar Plateau was selected as the representative area of soil erosion in the country. Along the route of Muree-Islamabad-Rawalpindi-Gujar Khan-Chakwal, 15 investigation units (12 small watersheds and 3 rectangular areas) were selected to investigate the types and characteristics of soil erosion, land use types and soil and water conservation measures, from April 16 to 20, 2019. Map interpreted in the early stage was manually recorded and Ovi interactive map APP was used for location photography to record the land use situation of each map spot in the survey unit. The land use situation was revised based on ArcGIS in the later stage. The overall soil erosion of woodland and grassland was relatively light with sheet erosion as the main type. Soil erosion mainly occurred in construction land. Gully erosion was caused by rainfall and runoff on excavated slopes, dump

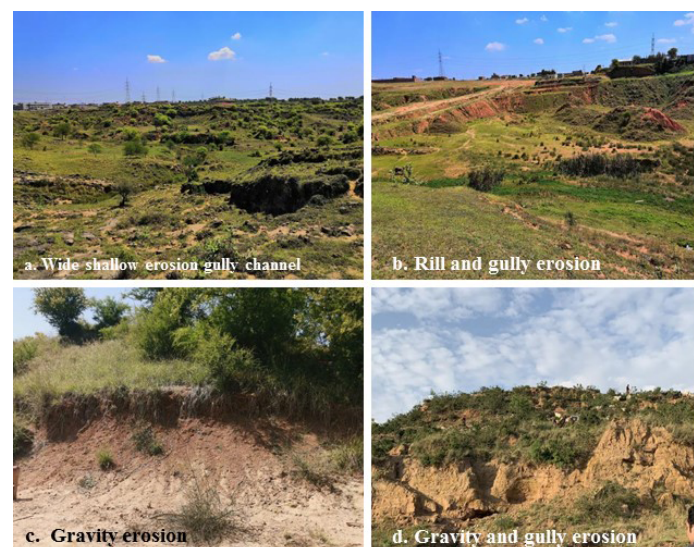
**Figure 3:** Soil Erosion of Grasslands (Sparse Trees) in Gujar Khan Region (Taken by Jiao Juying from 2019-04-18 to 2019-04-19).

**Characteristics of grassland soil erosion:** Within the investigation scope, the grassland is mainly distributed in Gujar-khan area of Rawalpindi (Unit 3-9). Its area can account for 16.70%~37.75% of the total area of the investigation unit, and the average soil erosion rate is between 0.99 ~ 30.65 t ha<sup>-1</sup> year<sup>-1</sup> (Table 2). The average annual rainfall in this region is 498~580 mm, which belongs to semi-humid climate. Under natural conditions, grass cover grows better and the erosion degree is lighter. Sheet erosion is distributed on the slope surface. The reason is that under the action of rainfall and runoff, fine soil particles in areas without vegetation cover are continuously transported, gravel is gradually exposed and severe erosion occurs. In addition, erosion gullies also occur on the surface under the action of long-term erosion (Figure 3a). Under the influence of human activities, the grassland has relatively serious soil erosion. As there is no vegetation measure to protect the soil

road slope, the soil is loose and the rainfall is easy to collect, resulting in a large amount of rill erosion and gully cutting in some areas (Figure 3b). Natural hillsides with high grass coverage were cut due to road repair, and areas without grass protection lost the consolidation effect of vegetation on soil, resulting in constant gravity erosion such as runoff and scattering, in sharp contrast to areas with grass coverage (Figure 3c). Grazing activities can cause serious damage to grass. Herbivores eat plant stems and leaves, affecting plant growth, reducing surface coverage; trampling makes surface soil compact, and its water storage performance decreases. Under rainfall conditions, runoff is usual, resulting in gravity erosion and gully erosion (Figure 3d).

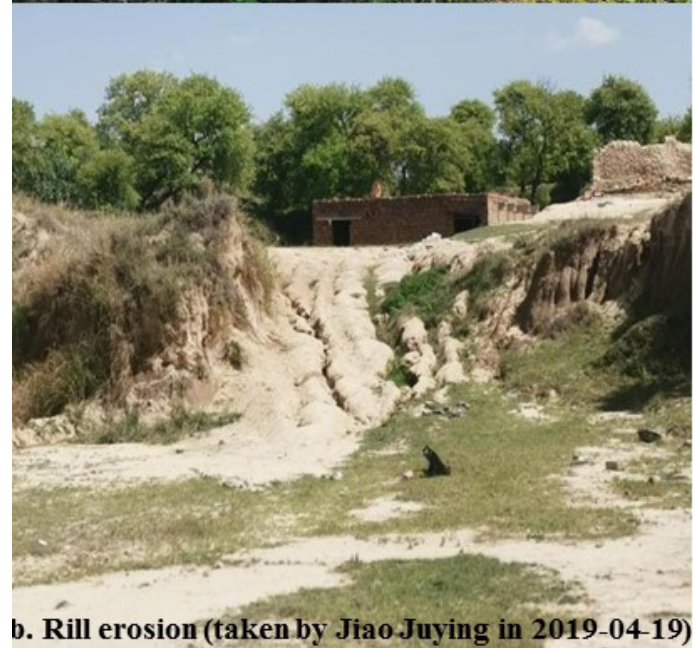
b. Rill erosion (taken by Jiao Juying in 2019-04-19)

**Figure 4:** Erosion Gully of Construction Land in Punjab and Northern Mindra in Islamabad Capital District.

discharging slope, the more rill and gully formed, and the greater the depth and width. Although the coverage of surface vegetation formed by abandoned soil along roadsides is relatively high, many large ditches are formed (Figure 4a, the ditches are about 30 m long, 0.5 ~ 2 m deep and 0.5 ~ 5 m wide), mainly due to the long surface slope formed after the abandoned soil is spread out, resulting in large runoff, and the soft soil, the grass cover layer cannot fully absorb water and disperse runoff, resulting in large ditches, causing serious damage to local land resources. In the 5th investigation unit (Figure 1), there are small brick factories. During the brick making process, a large amount of soil was taken, resulting in bare surface, reduced erosion resistance and gully erosion (Figure 1). As the surface of the earth is continuously compacted by vehicles, the soil infiltration capacity of the earth taking platform is greatly reduced, and the earth taking platform itself forms a large catchment area. Under rainfall conditions, the side slope of the earth taking platform is easy to generate fine ditches and cut ditches (Figure 4b). In addition to the above types of construction, there are also soil erosion to varying degrees in the construction of leveling ground and high-pressure towers, causing damage to local water and soil resources.

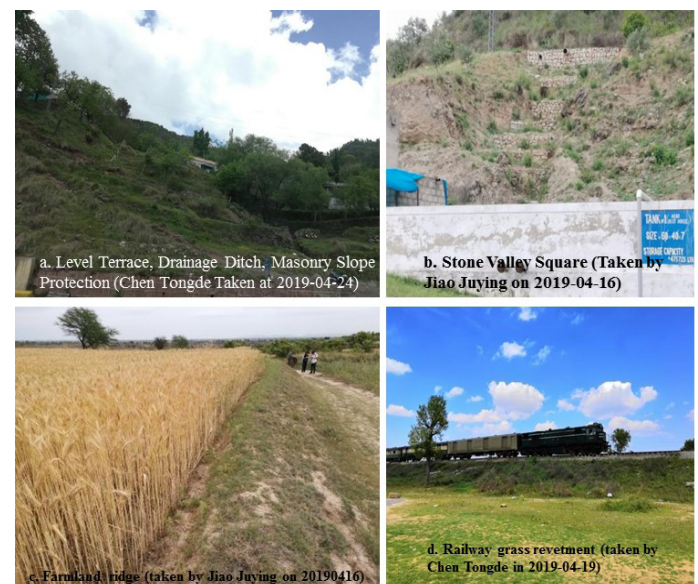
**Figure 5:** Types of Soil and Water Conservation Measures in Pothohar Plateau.

During this investigation, it was found that there are relatively few types of soil and water conservation measures in Pothohar Plateau, mainly including horizontal terrace stone masonry revetment for drainage ditches, small stone grain houses, farmland ridges, grass cover revetment, etc. (Figure 5). Horizontal terrace, masonry revetment (Figure 5a) and small dams (Figure 5b) are mainly applied to the Murree mountain area in the northern part of the Pothohar plateau, where the mountain is steep. For the sake of production safety, the local people usually excavate horizontal terraces according to the mountain. Masonry revetment is generally used on the adjacent slopes of horizontal terraces, and drainage ditches are used to guide and drain the horizontal terraces and the upper catchment water to prevent

the occurrence of traceable erosion and damage to the horizontal terraces. Small catchment is usually built at the outlet of the catchment area, and each dam is provided with a drainage pipe to achieve the effect of water removal and sand retention. Horizontal terraces are common in Murree mountain area. Most houses are built on horizontal terraces. At the same time, farmland is reclaimed around houses (similar to the Shikan terraces in China). Due to slope cutting and grading, the stability of horizontal terraces is very good. Besides, masonry or masonry revetment ensures that horizontal terraces are not washed away by runoff. These horizontal terraces have both production and ecological functions and are a kind of good soil and water conservation engineering measures in mountain areas. Within the scope of investigation, it is found that the gradient of farmland is very small, and farmland is seldom eroded, and most farmland is built with trapezoidal ridges of good quality (Figure 5c). This kind of ridge is quite different from that of China. The ridges in China are generally in the shape of a long strip, while the ridge in the Pothohar Plateau is a trapezoidal ridge with the inner side of the farmland being about 0.3 m long, the outer side being about 1.5 m long and the top being about 0.5 m wide. As the outer length of the trapezoidal ridge is much longer than the inner side, the stability of the trapezoidal ridge is better than that of the strip ridge. The ridge prevents the occurrence of soil erosion in the farmland and has a good protective effect on the environment inside the farmland. Although only simple grass cover is used for slope protection of railway slope (Figure 5d), the effect is good and no obvious soil erosion occurs, which may be due to the flat terrain, short slope and small catchments in the railway area is built, making it difficult to generate runoff during rainfall. In addition, about 0.2 m of gravel (ballast) was paved on train tracks. Rainfall enters the large pores between the gravel and do not converge to the railway slope.

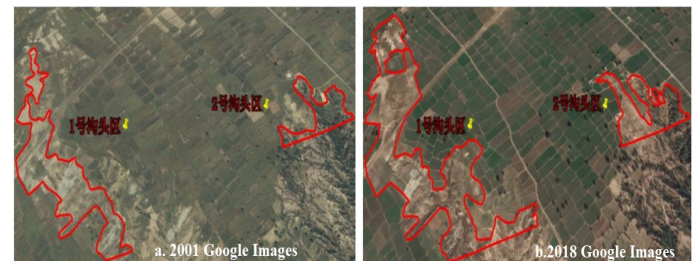
**Figure 6:** Gully head changes near research farm (URF) of PMAS Arid Agricultural University (near unit 4).

Pothohar Plateau is flat generally, with a large amount of cultivated land distributed. The land use results of the survey unit show that the proportion of cultivated land can reach up to 86.89%. At the same time, as a result of long-term hydraulic erosion, a large number of wide and shallow gullies are distributed on the plateau, and the gully area is still expanding. Take the gully area near the research farm (URF) of PMAS-Arid Agricultural University in Chakwal region as an example ([Figure 6](#)). The area of No.1 and No.2 gully expanded from 67,100 m and 26,046 m in 2001 ([Figure 6a](#)) to 154,838 m and 44,256 m in 2018 ([Figure 6b](#)) (the area is drawn in Google earth to obtain the area). The average expansion rate can reach 5,161.06 m/a and 1,071.18 m/a, respectively. This geomorphic type may be similar to the early state of the gully region of the Loess Plateau in China. Its

main geomorphic units include tableland and ravines. At present, a large number of researches on traceable erosion and gully protection have been carried out in China. If the gully head in the gully region of Pakistan is not treated, the landform type may evolve towards the landform in the gully region of the Loess Plateau (China), and a large amount of cultivated land will be destroyed.
